Duplicate Parts on ADI Integration

Last Modified on 12/11/2025 5:11 pm EST

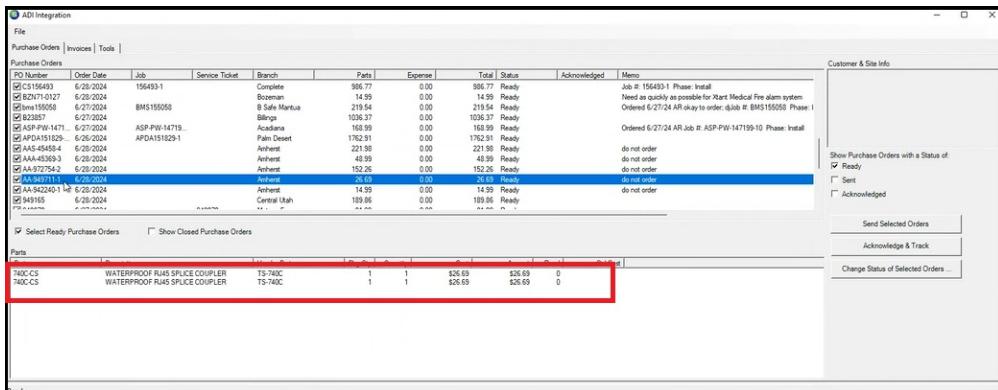
When using the ADI Integration, there is a low chance that you will see duplicate parts appear.

To resolve, you simply need to delete the extra vendor on the Part Edit.

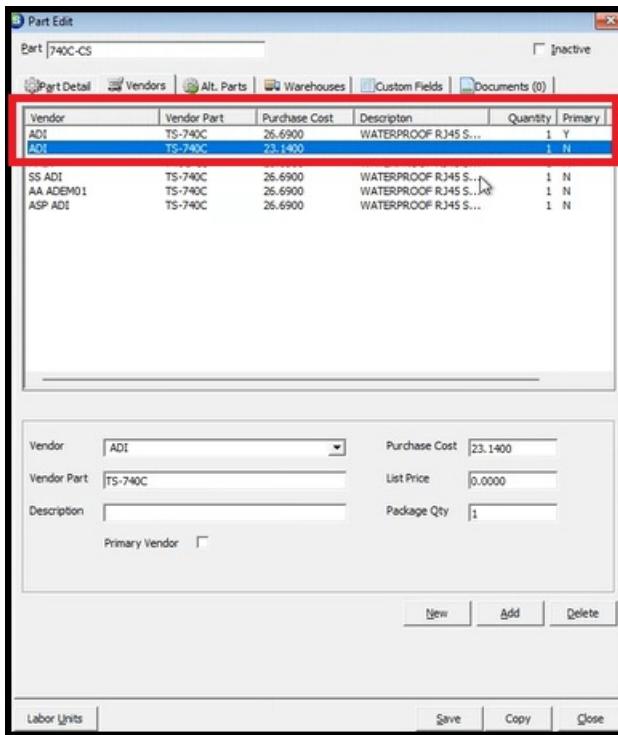
If you see this behavior occur, then check the Part Edit and look to see if the vendor is listed twice. The same vendor can be listed twice at different quantities, but if it is listed twice at the same quantity, this is a data error.

What is occurring in the data is that the IN_Part_Supplier has two entries for the vendor, which is causing the integration to pull two entries when it runs.
